Lifetime extension of the
French 1300 MWe reactor fleet
generic requirements for the
4th periodic safety review

Task 2: Operational experience Report

REPORT
REP-0935

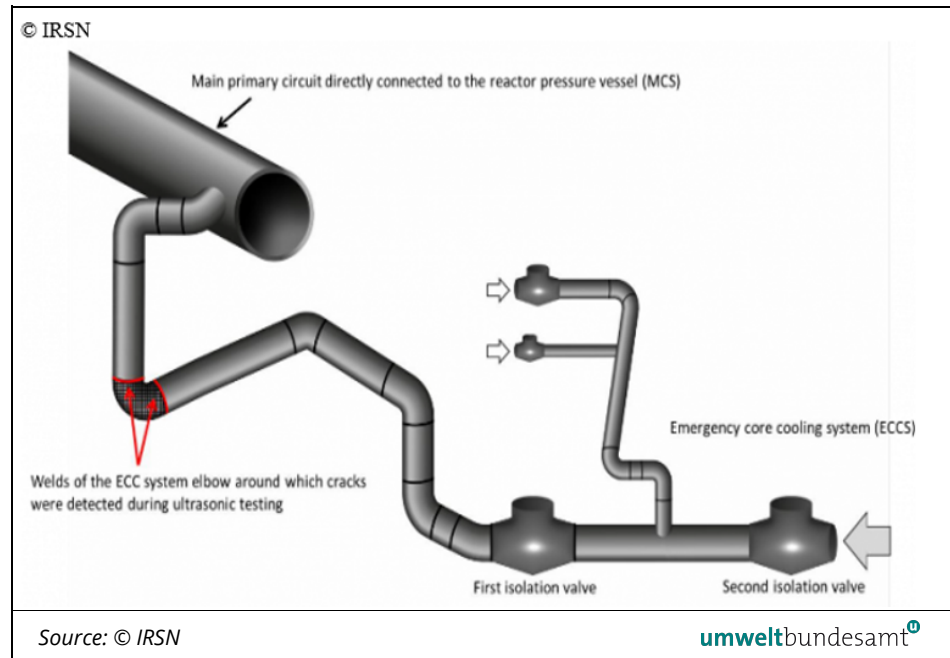
Figure 1
Location of the pipe sections affected by the findings

In numerous French reactor units, cracks have been found on weld seams in the safety feed systems (Figure 1).

The damage was first detected during the safety inspections of the pressurised water reactor at Civaux-1, which take place every ten years.

According to EDF (as of August 2022), the following are particularly susceptible to the corrosion phenomenon
