**Safety Relevant Issues and Measures:
Khmelnitsky 2 and Rovno 4 NPPs**

**Report to the
Ministry of Environment, Youth and Family
of the Republic of Austria**

Vienna, June 1997

Risk Research Report Nr. 14a

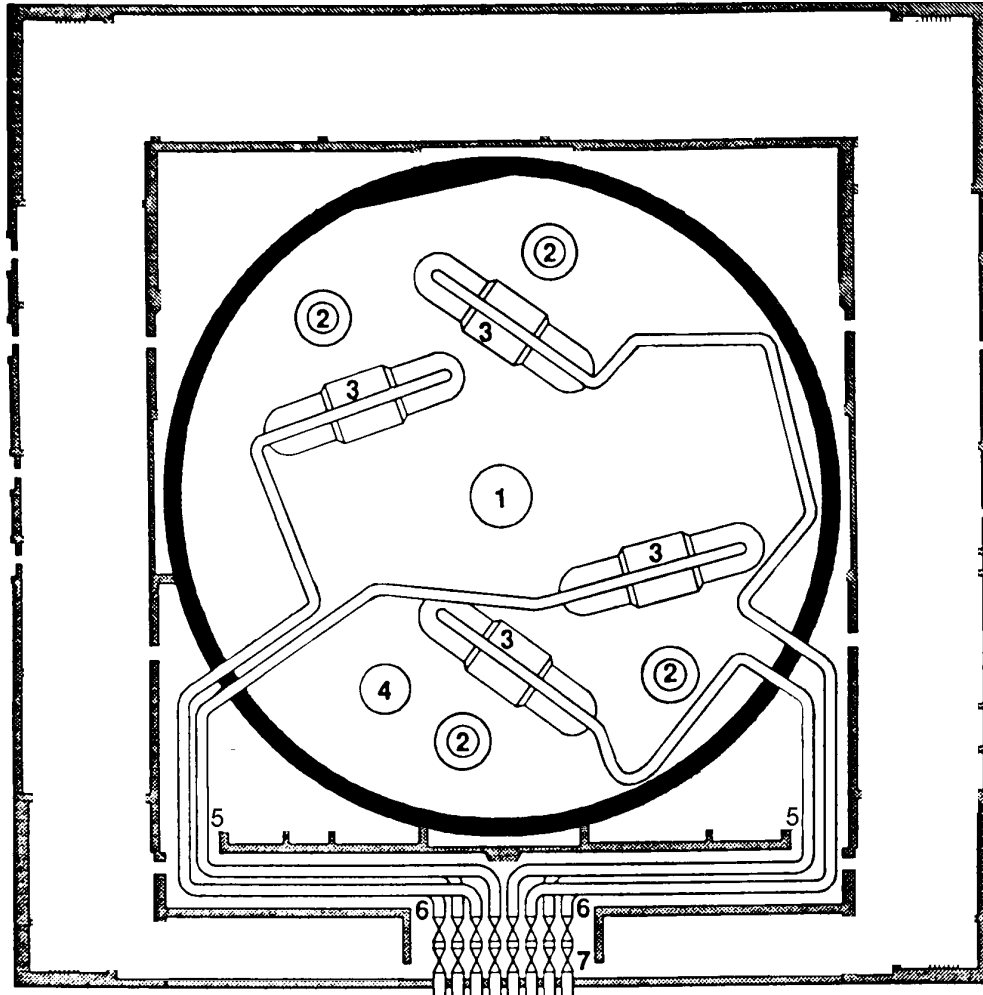
Figure 3 Reactor Building with Containment - Plan View (29.00 m Elevation)

1. Reactor Pressure Vessel
2. Primary Coolant Pump
3. Steam Generator
4. Pressurizer
5. Main Steam Line
6. Feedwater Line
7. BRU-A

A failure of the highly energized steam lines is a generic problem for all power reactors. For WWER-1000/V-320 reactors the problem is complicated by the closeness of steam lines and feedwater pipes not separated by protective shields on the 28.8 m level between reactor building and machine hall. (See Figure 3)

The WWER-1000 containment structure (see Figure 2 and 3) includes walls which are 1.2 m thick, a dome which is 1.0 meter thick, and a base which is 2.4 m thick. The base of the containment section is located about 13 m above grade. The foundation slab is 3.0 m thick. The containment liner is made by welded plates of stainless steel and is 0.8 cm thick. The design pressure of the WWER-1000 containment is 0.41 MPa above the surrounding pressure. The free volume of the containment is about 70,000 cubic meters (See Figure 1).
