**Second Hungarian – Austrian
Bilateral Professional Workshop on
the Paks II Site Conditions**

**Short Report to the Federal Ministry for Climate Action,
Environment, Energy, Mobility, Innovation and Technology (BMK)**

REPORT
REP-0919

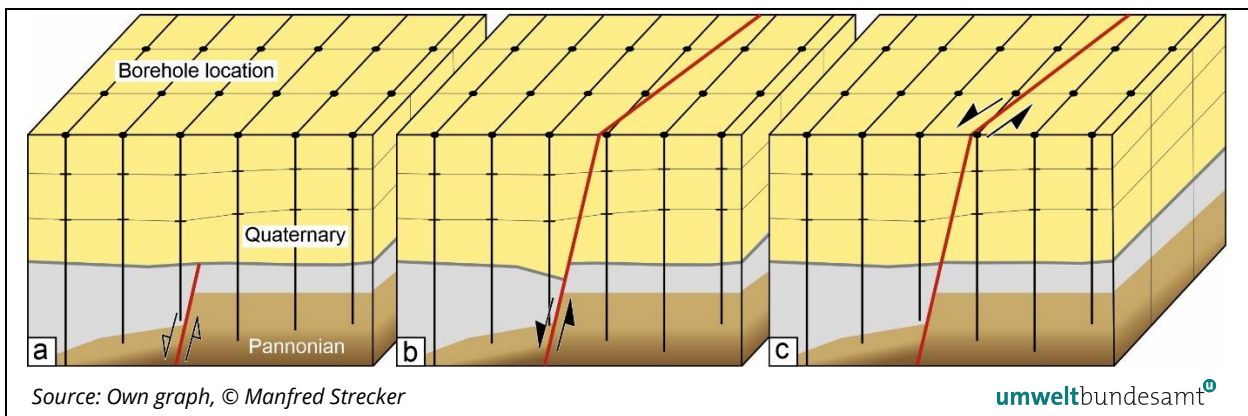
Figure 1: Geological profiles constructed from spaced boreholes cannot distinguish between (a) an inactive fault terminating at the base of the Quaternary strata, (b) a reactivated capable fault with vertical normal offset affecting Quaternary strata, and (c) a reactivated capable strike-slip fault with horizontal, but no vertical offset in Quaternary strata.

Given the kinematic history of the DHFZ and the offsets of Quaternary sediments recorded along other faults in the region it is likely that similar small offsets at decimeter scale cannot be detected in geological profiles constructed solely with borehole information (Figure 1). Likewise, offsets in Quaternary sediments would be virtually impossible to verify by drilling if the Quaternary kinematic style has been characterized by strike-slip faulting. In combination with the currently available database this uncertainty could only be resolved by paleoseismological trenching.

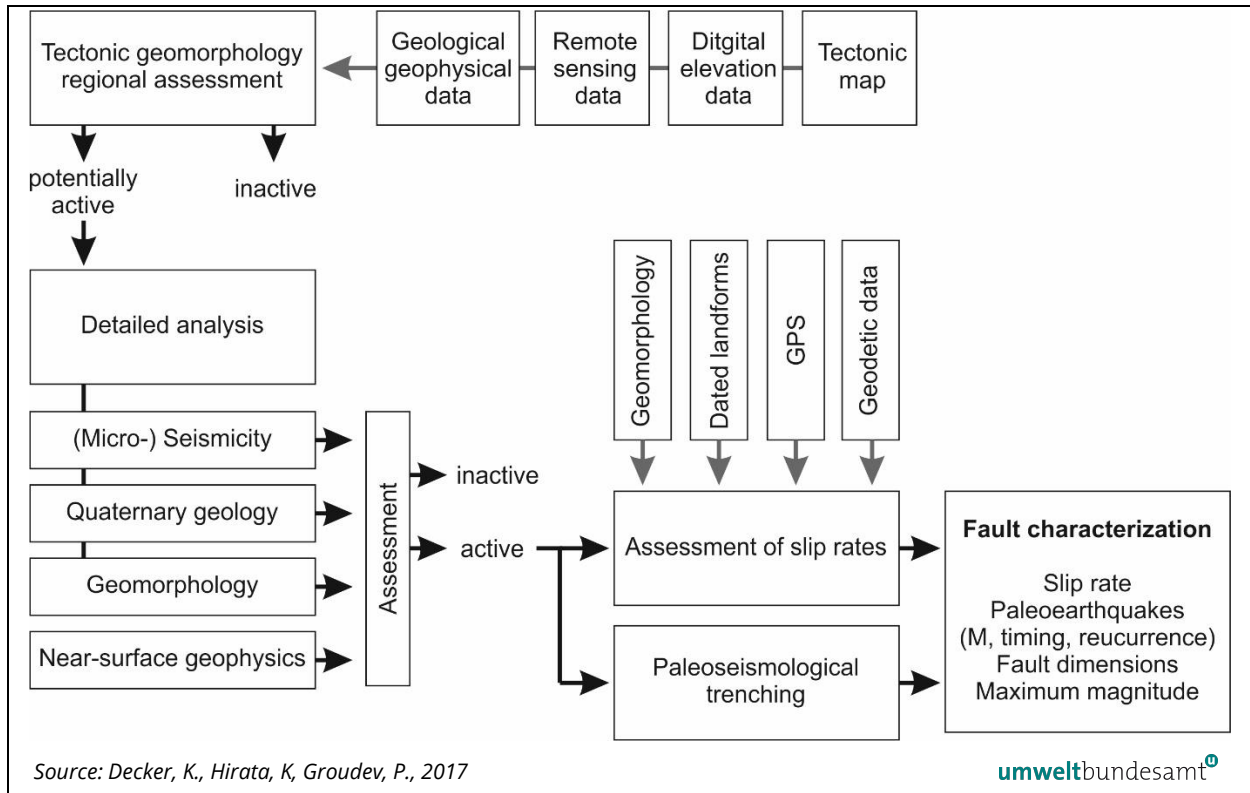
APPENDIX 2

Decker, K., Hirata, K, Groudev, P., 2017: Flow chart of the graded approach for the identification and assessment of active / capable faults in the near-region and region of a site (Fig. 14, p. 71).
