# **WORKSHOP ON THE PAKS II SITE CHARACTERISTICS**

*Assessment of the Hungarian-Austrian  
professional workshop on the Paks II site  
characteristics in Budapest, Feb 15, 2022*

REPORT  
REP-0828

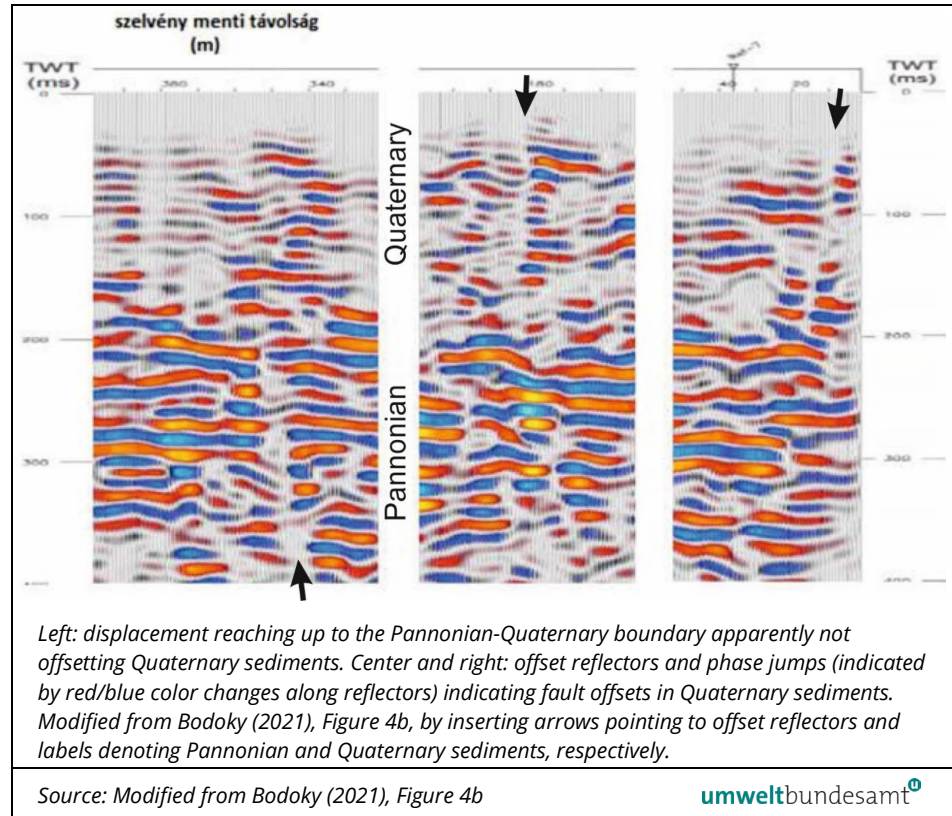
Figure 1.  
Phenomena depicted by  
S-wave reflection seismic  
lines from the Paks II site  
that cannot be inter-  
preted as surface noise,  
and thus indicate fault  
offsets.

In a later interpretation of the same S-wave reflection profiles, T. Bodoky (2021) introduced a method for discriminating between seismic signals derived from the anthropogenic backfill and reflection patterns indicative of faults. This approach, in which “phase jumps” (sudden phase changes along a traceable seismic horizons) are reliable indicators of fault offsets, led to the identification of numerous faults cutting the top of the Pannonian strata and continuing upwards into the overlying Quaternary sediments (Figure 1). The data allow tracing faults up to a minimum depth of about 50 ms shear wave TWT (circa 7 meters according to the s-wave velocity estimated by Bodoky, 2021). Bodoky (2021, p. 212) concludes that the shear-wave reflection data makes it “*quite certain*” that Quaternary sediments are faulted. Bodoky (2021) further provided a map of the Paks II site showing the locations of faulted or fractured zones (“*törésez zavart zona*”). A tentative interpretation of the 15 S-wave reflection lines included in Ács et al., 2016, Attachments 4–7 by the EAA experts revealed similar results (Figure 2). The EAA experts only considered faults that were interpreted to affect overlying Quaternary sediments. The results of both interpretations highlight numerous fault/fracture zones (Bodoky, 2021) and fault sticks (EAA experts) within the Paks II site area (Figure 2). Fault sticks tend to line up along SW-NE- to SSW-NNE-striking structures, i.e., parallel to the strike of the Dunaszentgyörgy-Harta fault zone.

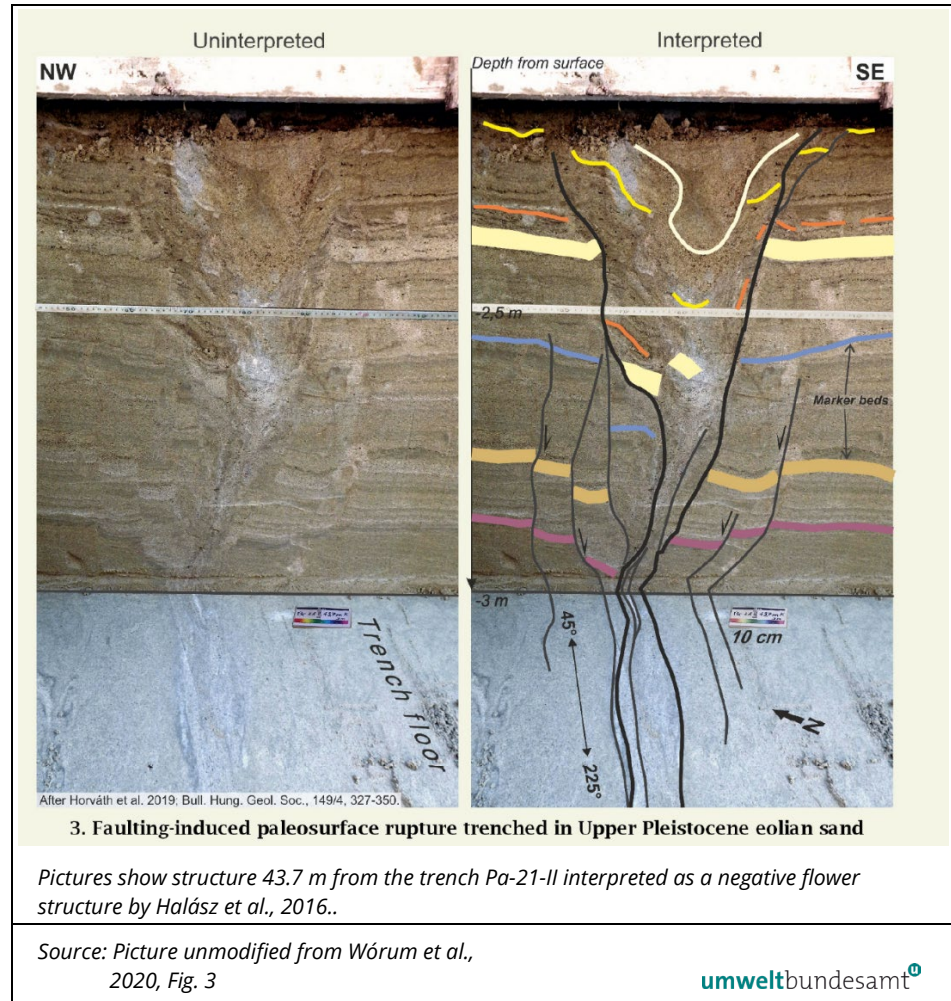
Figure 3.  
Surface-breaking fault excavated in the trench Pa-21-II serving as “an example of characteristic neotectonic deformation features” in the map of Young Geological Deformations in Hungary by Wórum et al. (2020).

Furthermore, in the man-made trench Pa-21-II, deformation of near-surface sediments was recorded. The identified structures offset 20-ky-old floodplain sediments (Halász et al., 2016, Attachment 2, trench log). Based on paleoseismological criteria (e.g., McCalpin, 2009, Fig. 6.34, Fig. 6.35) these structures are related to fault offsets. The arrangement of the offset strata is related to a brittle deformation process and cannot be mistaken for a sedimentological feature that might have been caused by paleoclimatic conditions under a periglacial regime (e.g., ice-wedge fill). Neither can these features be explained as liquefaction phenomena associated with the upward escape of water-saturated sediment, such as those described by Obermeier (1996) or Tuttle (1999, 2001). A tectonic interpretation of the described features by Halász et al. (2016) has also been adopted by Wórum et al. (2020). In their map of Young Geological Deformations in Hungary, Wórum et al. (2020, Fig. 3) show a structure from the trench Pa-21-II as an example of characteristic neotectonics deformation features (Figure 3).

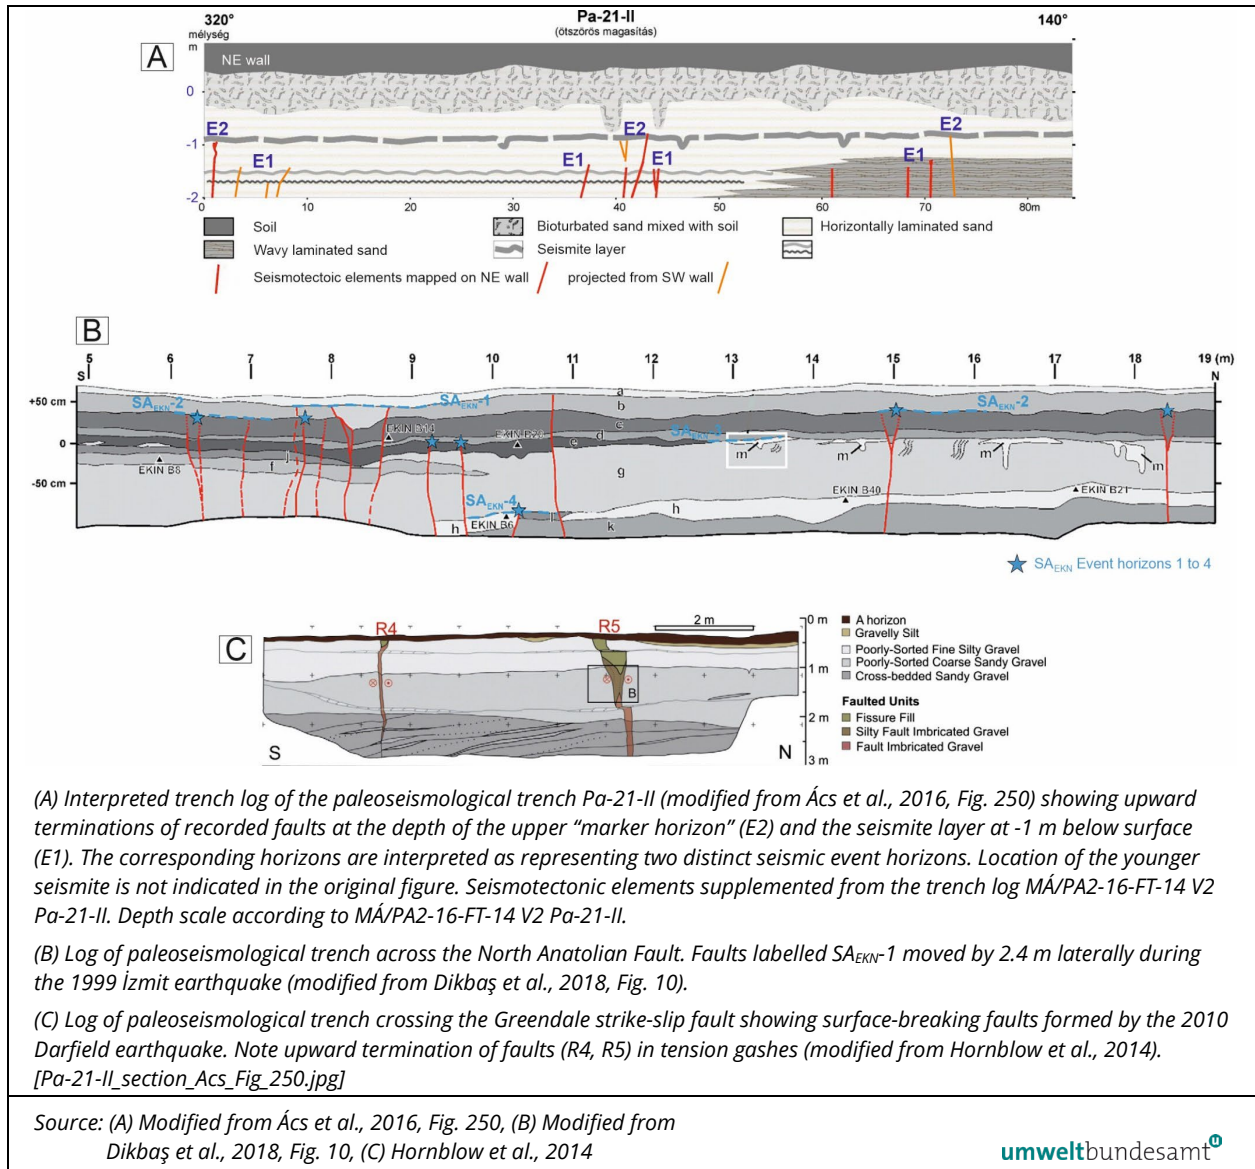
Figure 4. Comparison of the paleoseismological trench Pa-21-II with trenches exposing surface-breaking faults that ruptured during recent strike-slip earthquakes.

The structures observed in Pa-21-II are strikingly similar to published trench observations across strike-slip faults, such as the faults related to the 1999 Izmit (Turkey) Mw=7.4 and the 2010 Darfield (New Zealand) Mw=7.1 earthquakes (Dikbas et al., 2018; Hornblow et al., 2014): They all show very narrow sub-vertical deformation bands with no or small vertical offset distributed over the length of the respective trench walls. The faults terminate upwards in sediment-filled fissures. The similarities to the published trench studies support the interpretation of the observations in trench Pa-21-II as the result of at least two surface-breaking earthquakes along a strike-slip fault (Figure 4). In addition, both studies conclude that vertical offset observed within the trenches underrepresent the total surface offset related to the respective earthquake. Hornblow et al. (2014) even state that only approximately 30% of surface displacement that occur in strike-slip earthquakes are manifested along surface-breaking faults. Therefore, the slip estimation of only few centimeters along the Dunaszentgyörgy-Harta fault zone based on the trenching observation must be considered as an absolute minimum offset.

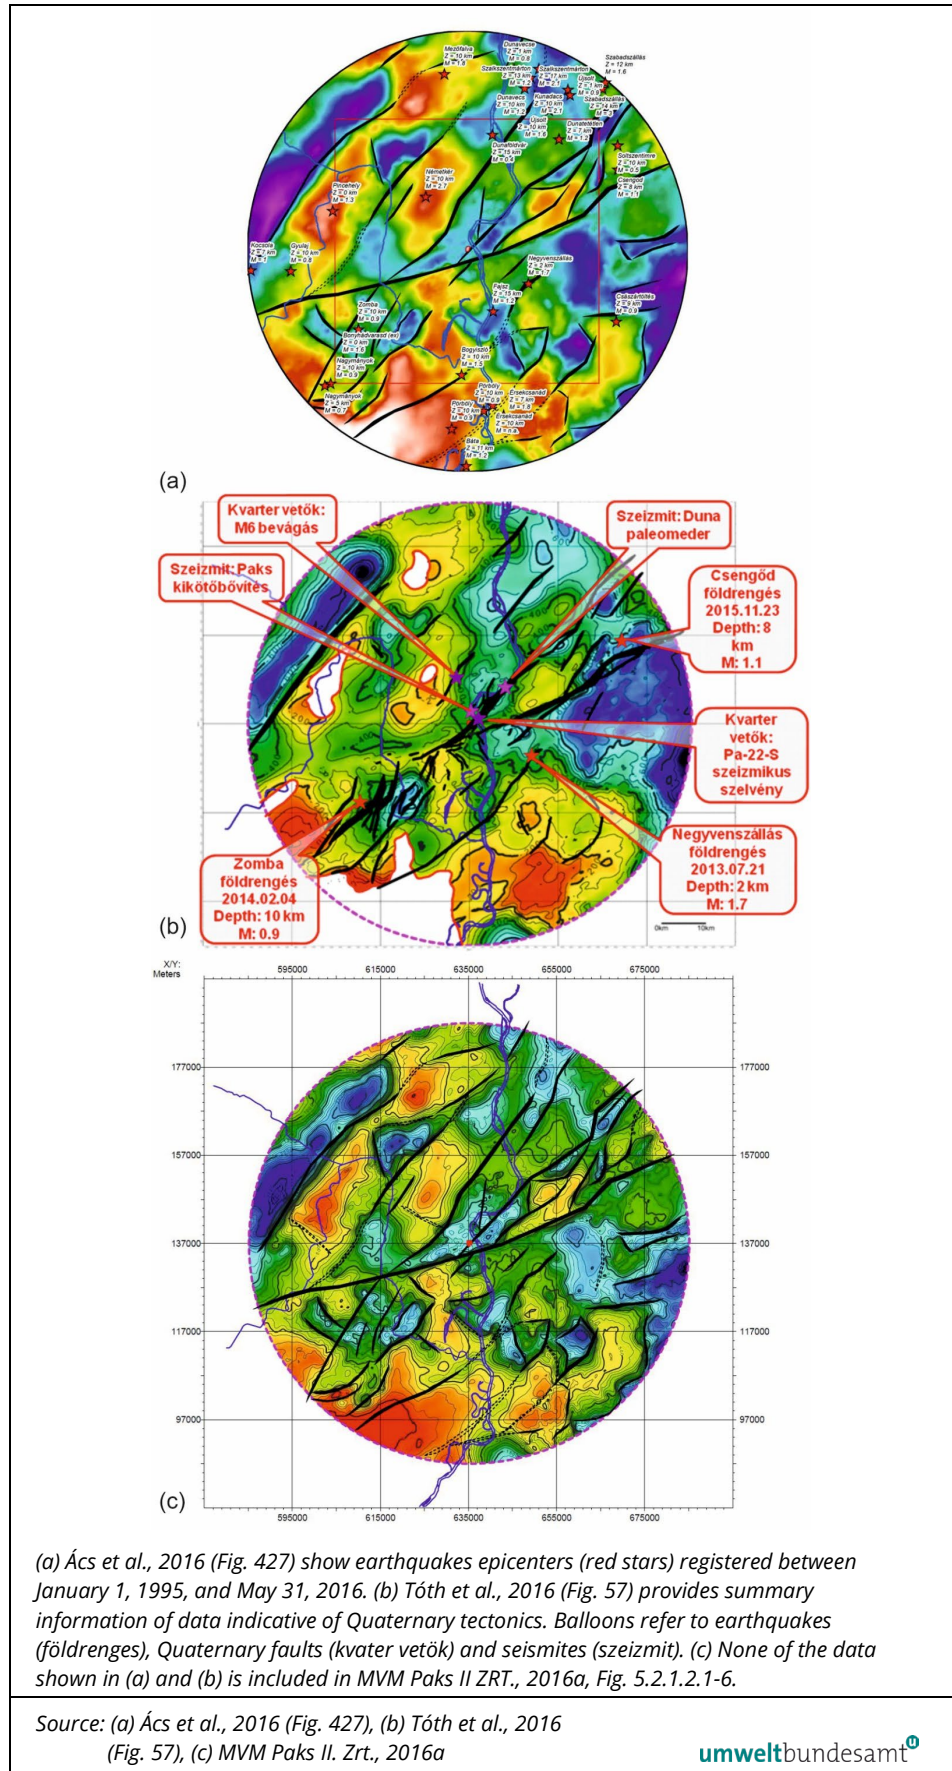
Figure 5. Comparison of maps showing fault locations within a 50 km radius of the Paks II site on the background of a depth structure map.

al., 2016, Fig. 57; Ács et al., 2016, Fig. 427; and MVM Paks II ZRT., 2016a, Fig. 5.2.1.2.1–6 (Figure 5).

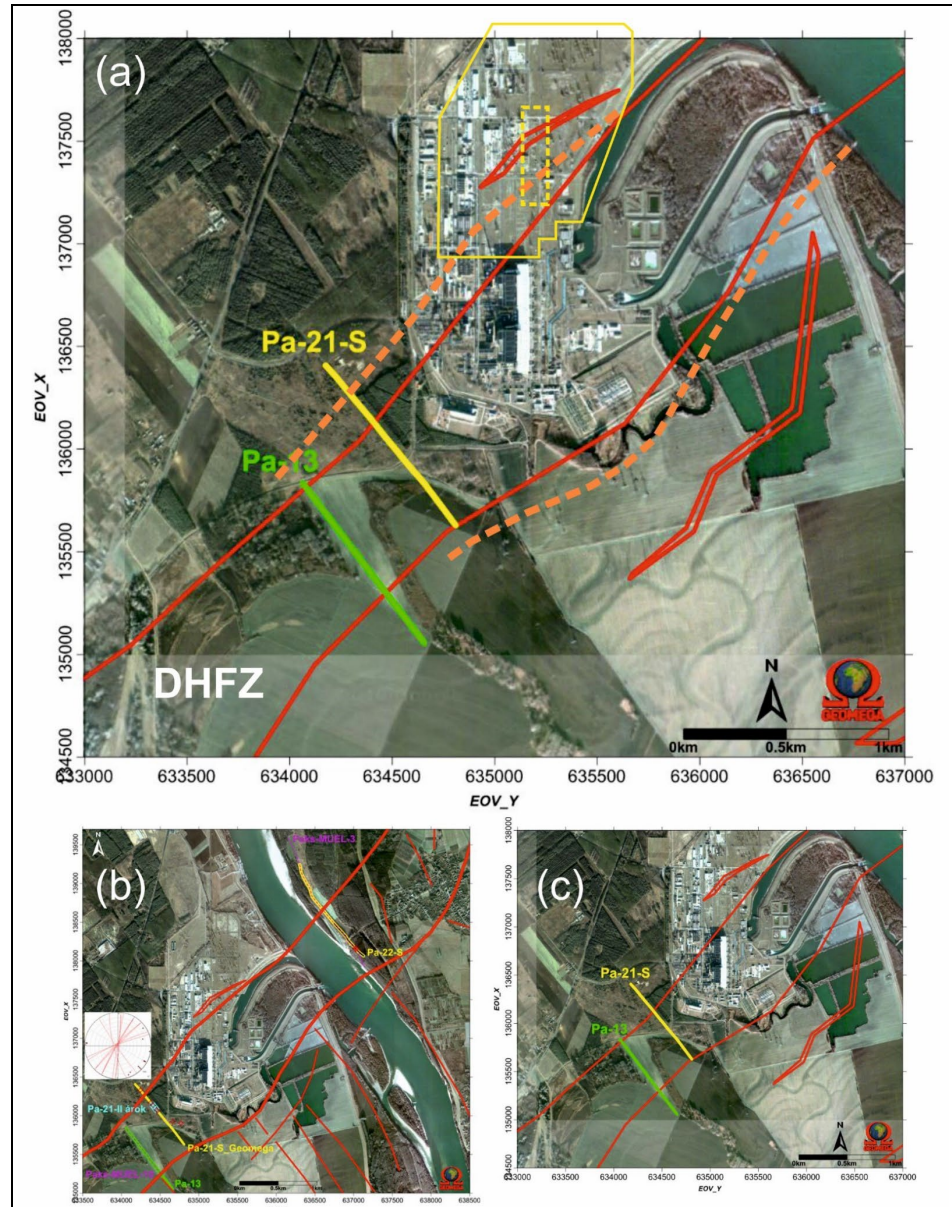
Figure 6.  
Comparison of the  
location of the  
Dunaszentgyörgy-Harta  
fault zone (DHFZ) and  
accompanying branch  
faults (red polygons)  
shown by Paks II Zrt.,  
2016a

(a) Comparison of the location of the Dunaszentgyörgy-Harta fault zone (DHFZ) and accompanying branch faults (red polygons) shown by Paks II Zrt., 2016a, Fig. 5.2.1.2.6-1. (red lines) and Ács et al., 2016, Fig. 418, p. 700 (orange broken line). The width of the fault zone indicated by Ács et al. (2016) extends farther north into the perimeter of the new reactor blocks. The yellow polygon denotes the site of Paks II according to the geographic coordinates listed in HAEA (2017). The yellow broken line indicates the approximate position of the reactor blocks of Paks II (from <https://www.paks2.hu/kozerthetoen-a-letesitesi-engedelyezesrol>). Unmodified maps are shown in (b) and (c): (b) Location and extent of the DHFZ indicated in the Geological Site Report, Ács et al., 2016, Fig. 418, p. 700. (c) Location and extent of the DHFZ shown in the Site Safety Report, MVM Paks II Zrt., 2016a, Fig. 5.2.1.2.6-1. [Paks\_II\_site\_map\_fault\_location\_MVM\_Paks.jpg]

- the location and extent of the DHFZ below the Paks II site as shown by Ács et al., 2016, Fig. 418; and MVM Paks II ZRT., 2016a, Fig. 5.2.1.2.6–1 (Figure 6).
- the disregard of paleoseismological evidence for the occurrence of ground-rupturing earthquakes in the last 30,000 years included in different parts of the report by Ács et al. (2016; for a compilation of the data and references see Decker & Hintersberger, 2021, Tab. 1)

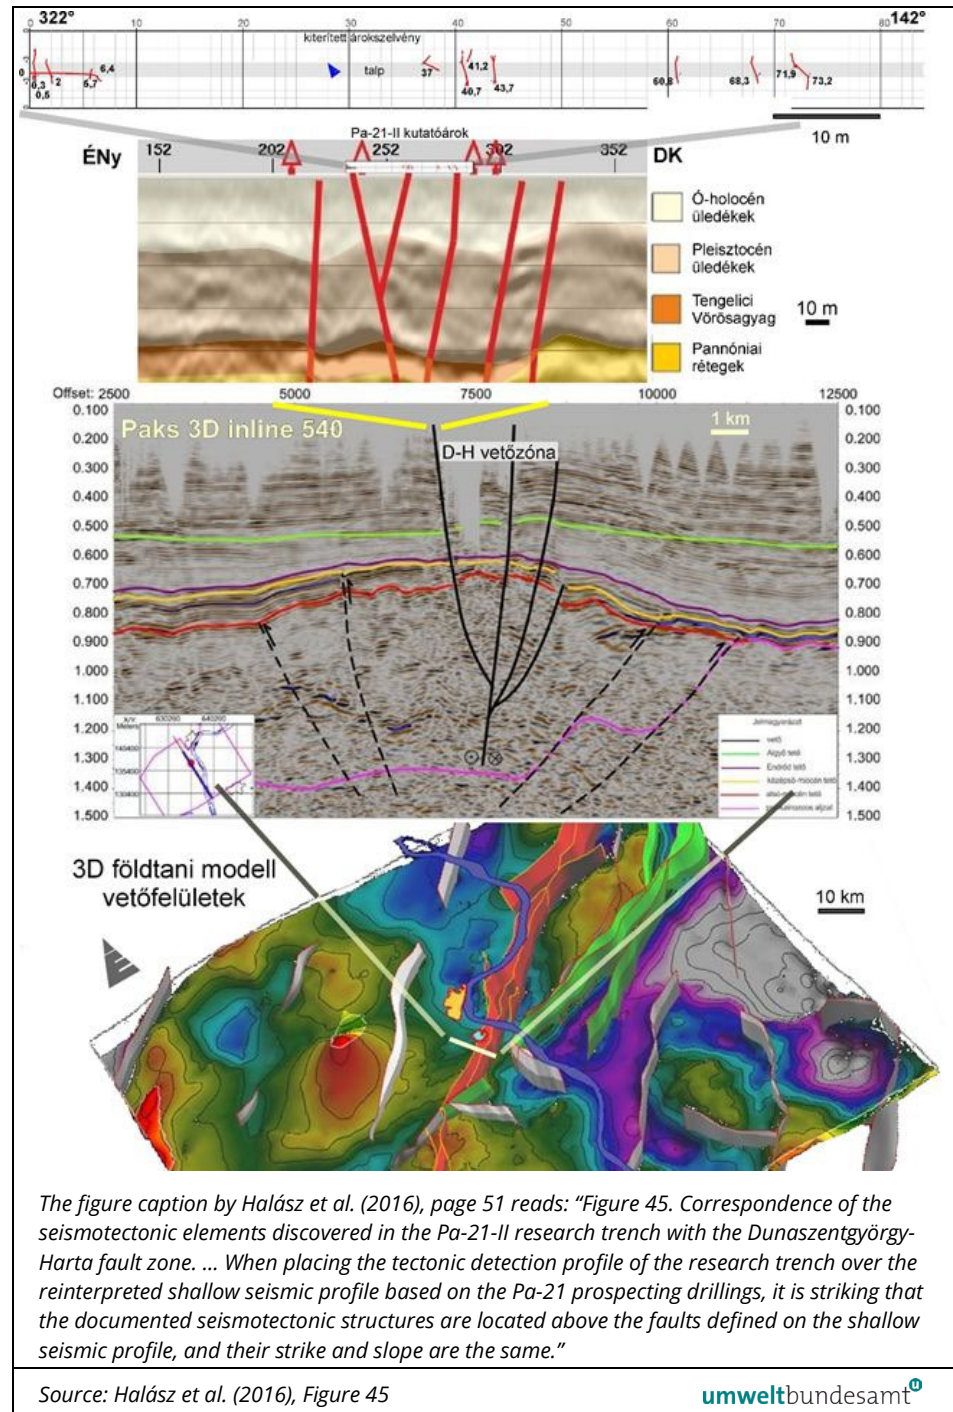
Figure 7.  
Location of the trench  
Pa-21-II above the  
Dunaszentgyörgy-Harta  
fault zone (DHFZ) shown  
in Halász et al. (2016),  
Figure 45.

The statement by Konrad et al. (2021) contradicts the earlier interpretation of the same authors illustrated and described in Halász et al. (2016), page 51, Figure 45. The cited figure explicitly links the faults in trench Pa-21-II with the deep structure of the Dunaszentgyörgy-Harta fault zone (Figure 7):

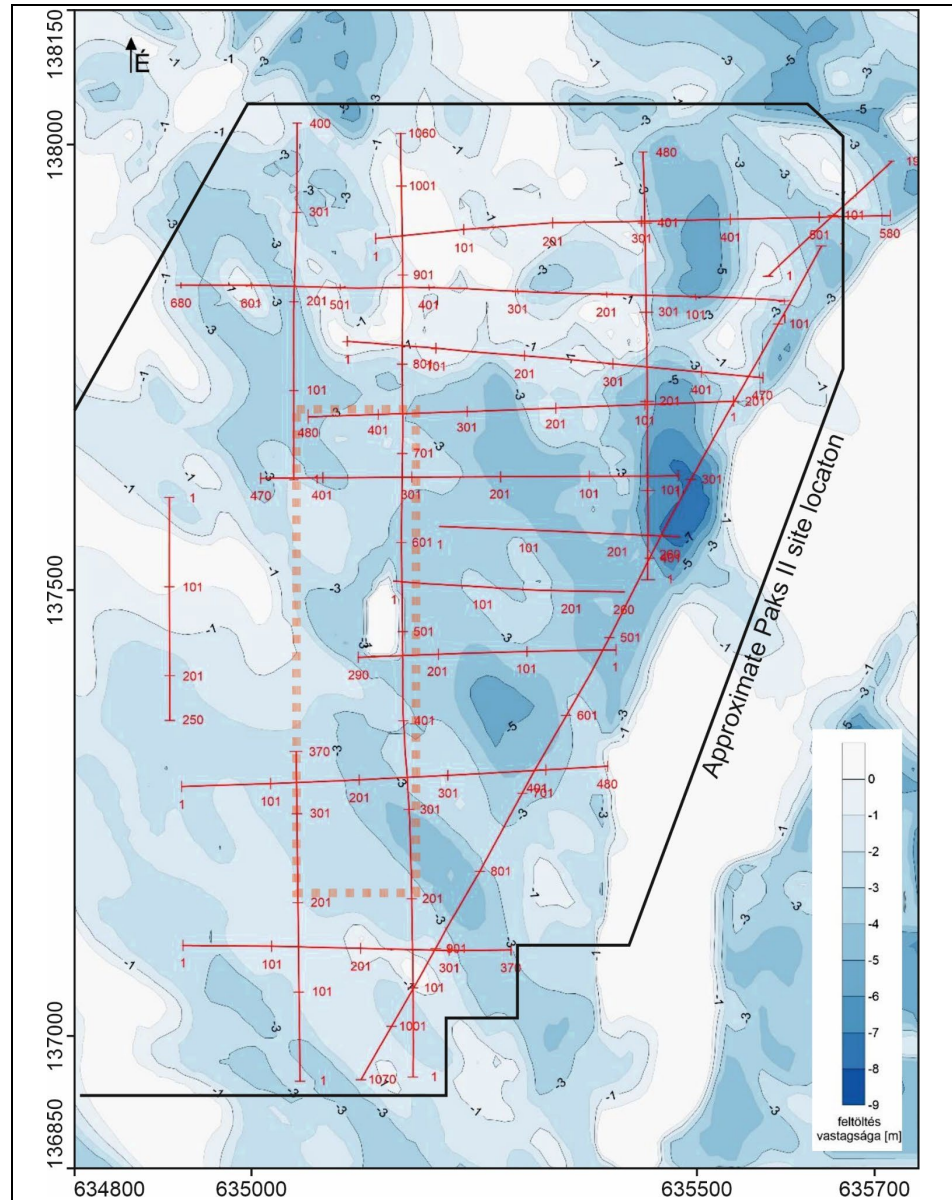
Figure 8. Thickness map of backfill at the Paks II site

Color code denotes filling thickness (feltöltés vastagsága). Modified from Tóth et al., 2016, Fig. 77, by adding the approximate location of the Paks II site and the expected locations of the reactor buildings. [Toth\_Fig\_77\_thickness\_antropocene.jpg]

Tóth et al. (2016, Fig. 77) provide a thickness map of the anthropogenic fill at the Paks II site, which shows that backfill covering natural soil is in some places much less than 5 m thick (Figure 8). It thus seems that the first phase of excavation will also affect the uppermost and youngest layers of sediments deposited as a result of natural processes. Documenting whether the latter layers are undeformed or penetrated by faults is of utmost importance for a rigorous paleoseismological assessment. Proper documentation should therefore be required from the very early stages of excavation.
